# Holden Mine Remediation Project Update

**July 2016**

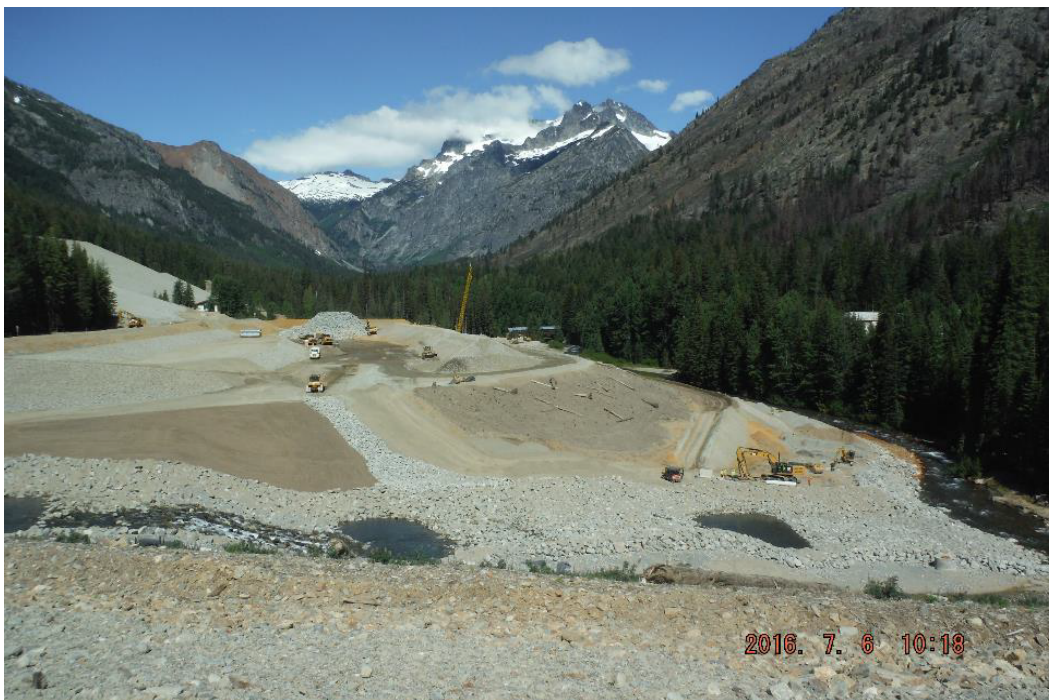
## **Overview of activities at Tailings Pile1**

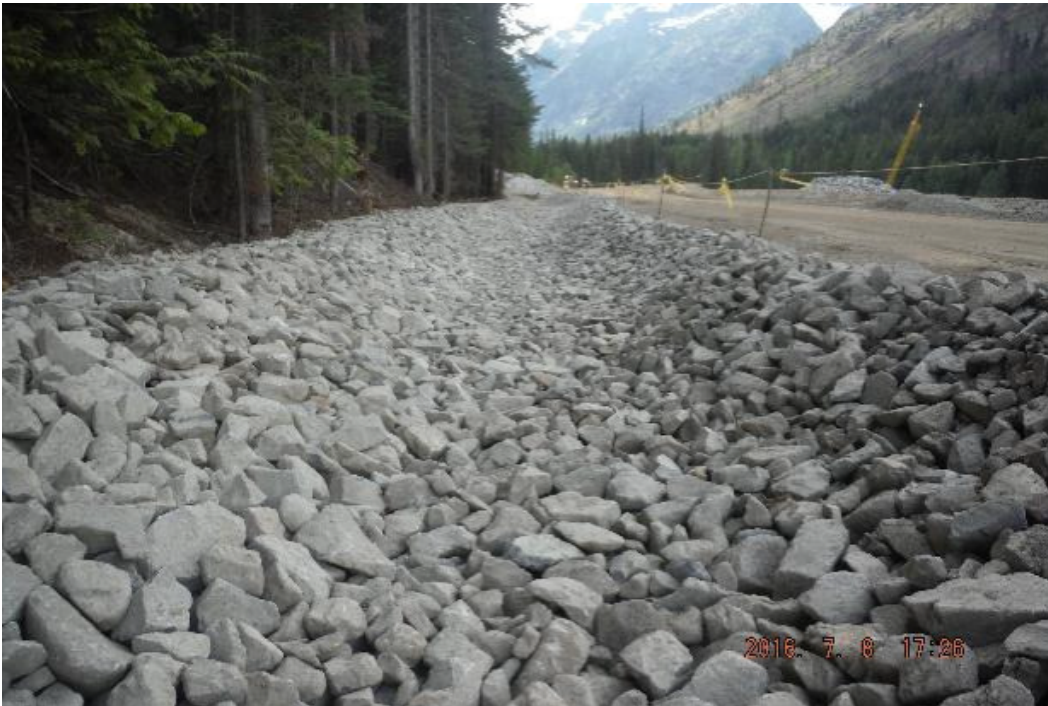
Good progress was also made on the construction of the interceptor channels around the tailings piles. These interceptor channels will collect storm water and surface water and divert that water from flowing into the tailings piles and becoming contaminated. Collecting this water before it reaches the piles will help decrease the work load on the Mine Water Treatment Plant.

**View of Interceptor Channel-3 south of Tailings Pile 1 looking west**

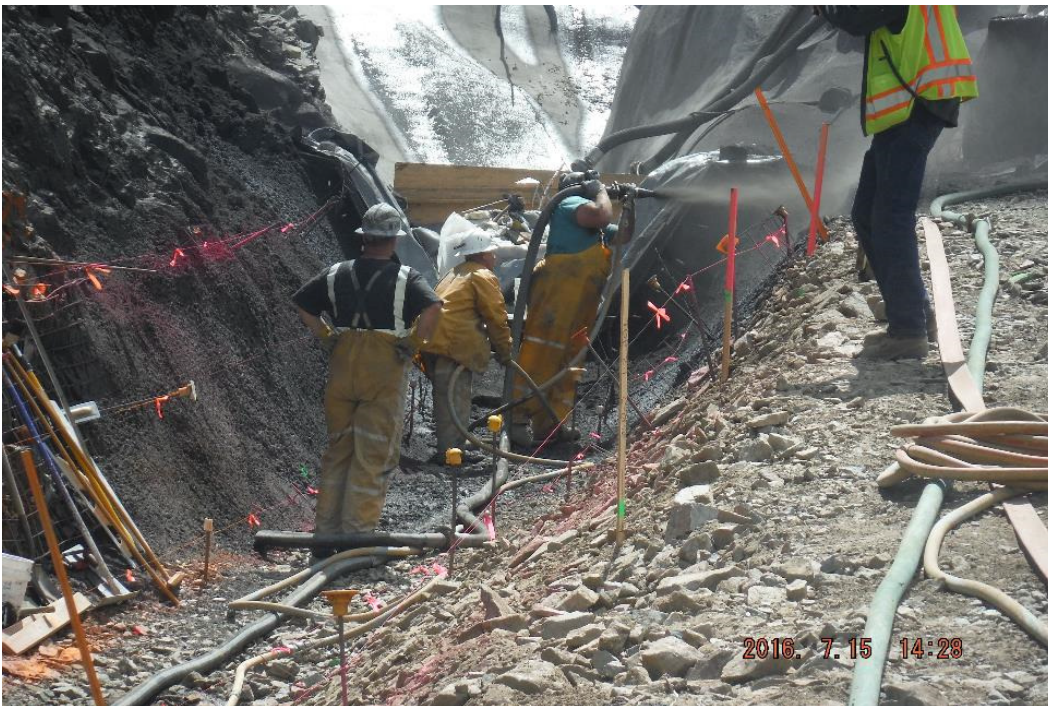
**Shotcrete Channel – placing shotcrete on STP-3 water diversion channel**

A diversion channel was also constructed around the borrow site south of Tailings Pile 3 (STP3 Borrow). The “shotcrete channel” will collect and divert clean water around STP3 Borrow to reduce the amount of water infiltrating Tailings Pile 3 and requiring treatment. The channel was constructed, then fortified with colored shotcrete.
